# MERSEY RIVERCARE PLAN

## 2 - DASHER - MINNOW

NOVEMBER 2000

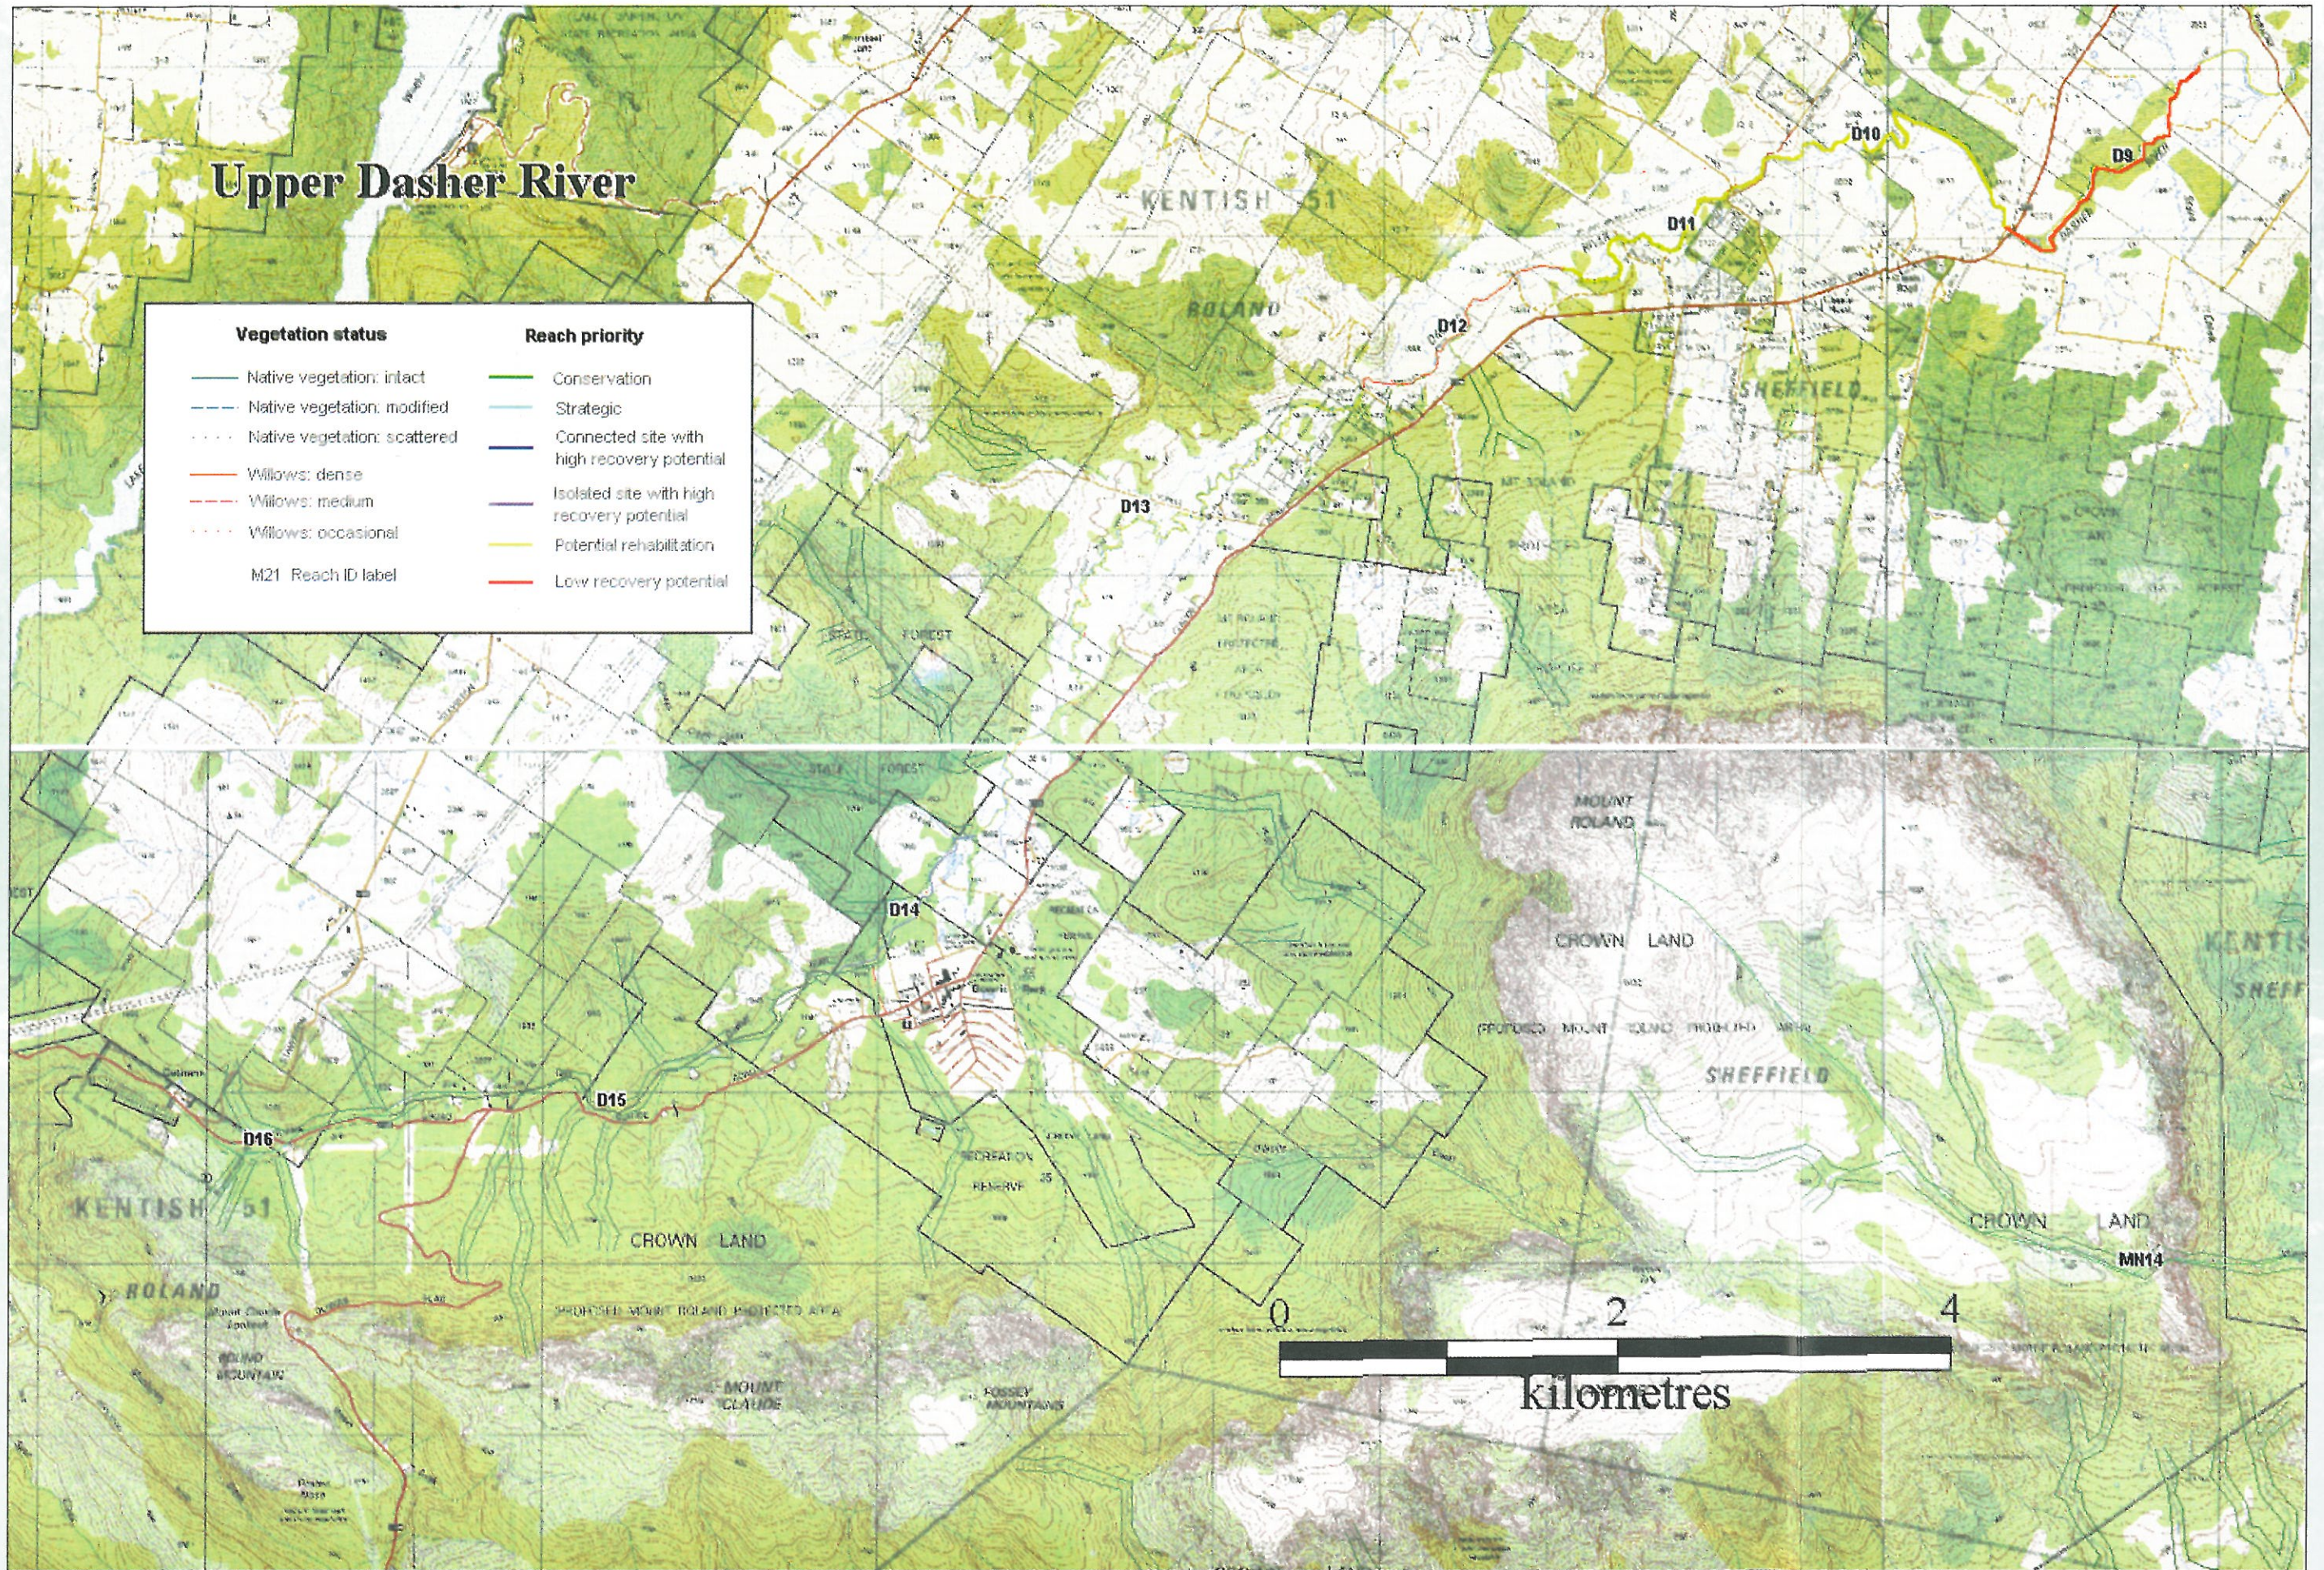
# Upper Dasher River

Vegetation status	Reach priority
Native vegetation: intact	Conservation
Native vegetation: modified	Strategic
Native vegetation: scattered	Connected site with high recovery potential
Willows: dense	Isolated site with high recovery potential
Willows: medium	Potential rehabilitation
Willows: occasional	Low recovery potential
M21 Reach ID label
